# Technical Service Bulletin

<b>Subject:</b>  RATTLING, CLUNKING OR POPPING NOISE FROM FRONT OF VEHICLE WHILE DRIVING	<b>Bulletin No.:</b> 09-030/21
	<b>Last Issued :</b> 10/13/2021

2016-2021 CX-9

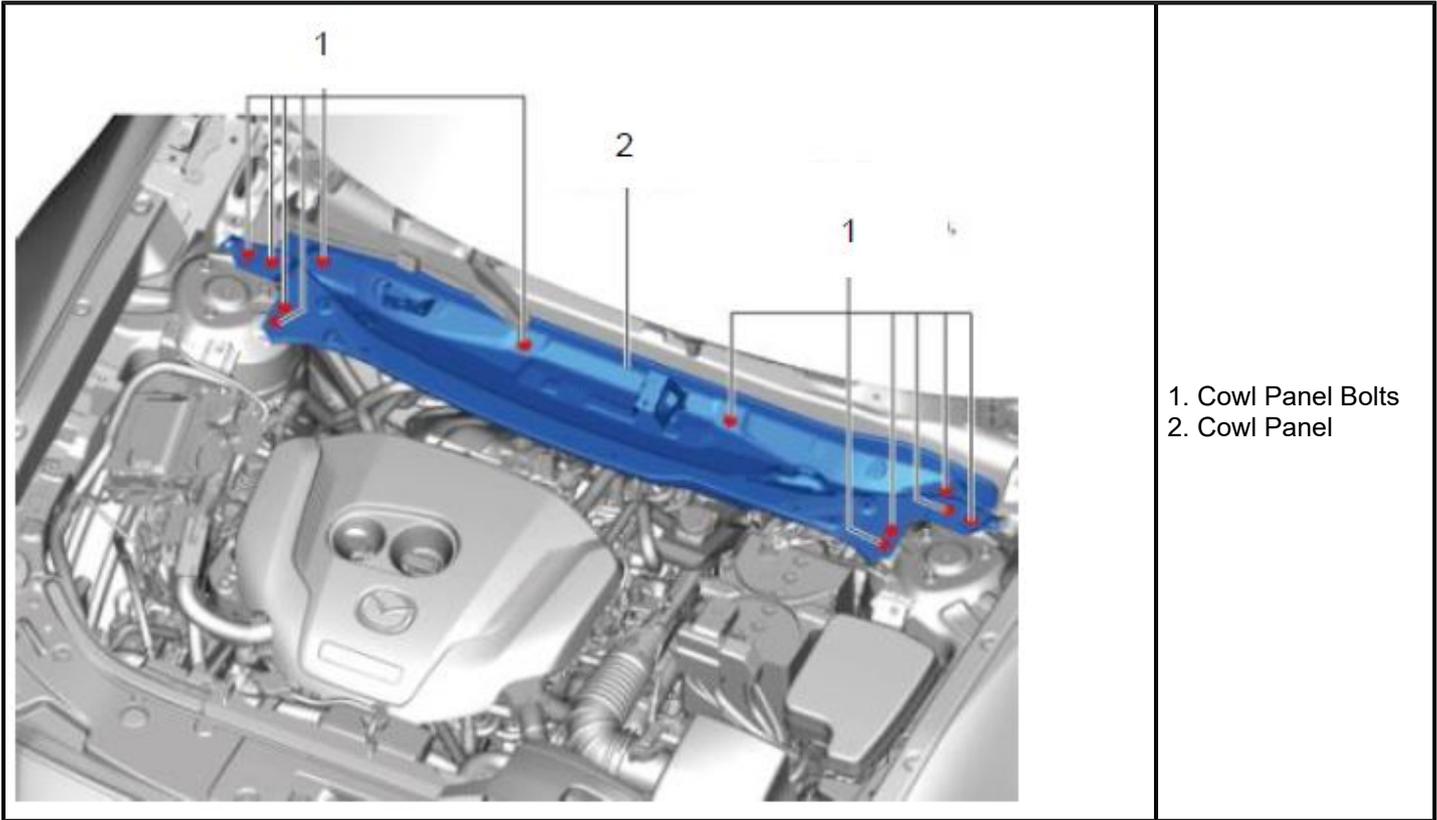
1. Cowl Panel Bolts  
2. Cowl Panel

Some vehicles may exhibit a rattle, clunk or pop noise from the front of the vehicle while driving. The noise may be caused by loose cowl panel bolts.

1. Verify the customer concern.
2. Tighten all cowl panel bolts according to the instructions on MGSS online (COWL PANEL REMOVAL/INSTALLATION).

- Tightening Torque: 29 ft.-lbf. {40 kgf-m, 40 N-m}
